To: Dan Smith, Steve Craig; City of Tumwater Subject: FINAL Technical Memorandum

From: Stephen Booth, Ph.D., Project: Water Quality Evaluation at the Lathrop
Michael Hallett; Confluence Water System

Date: April 19, 2017

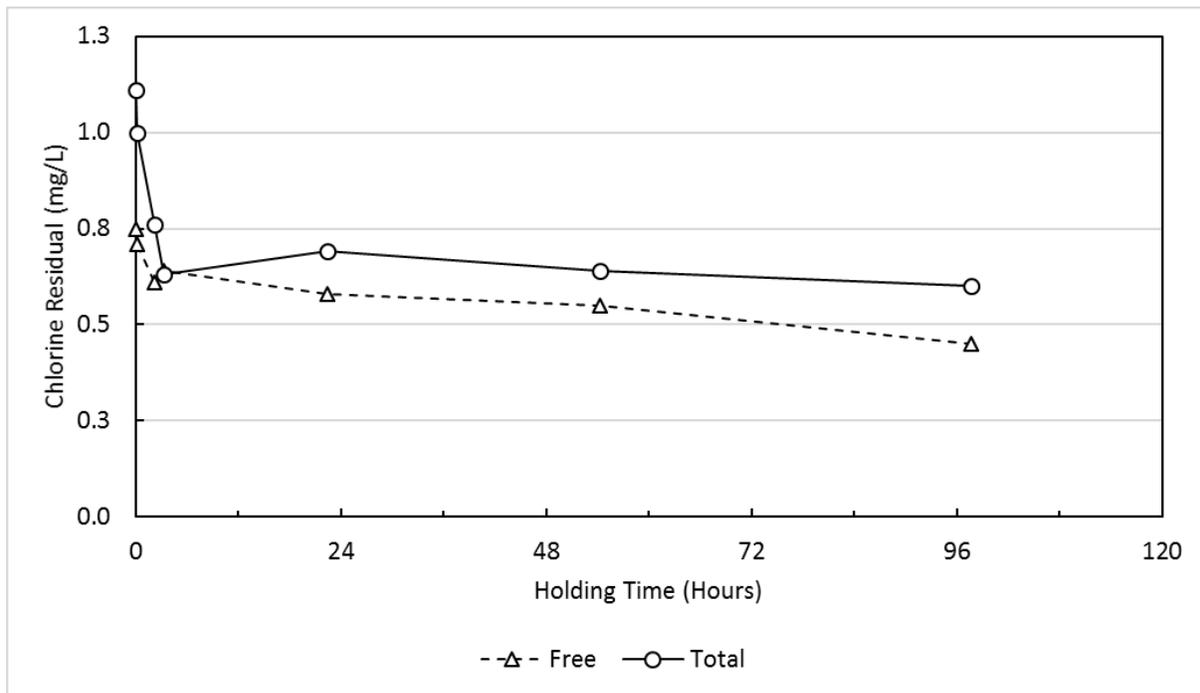
Figure 1. CDD curve for treated water.

A CDD curve for the treated well water is presented in Figure 1. Most of the CDD is associated with oxidation of native iron and ammonia in the raw water causing chlorine residuals to decrease significantly within the first 2 to 3 hours of holding time. Subsequent CDD appears to be relatively minor with a decrease of only approximately 0.2 mg/L between the 24-hour and 96-hour holding times. These results are consistent with chlorine residuals measured in the system which indicated that most of the CDD occurred within the reservoir and little CDD was associated with the distribution system.

- Increasing the chlorine dose to provide a residual of at least 0.6 mg/L in the reservoir outlet water is recommended. A higher residual in the distribution system is anticipated to help control bacterial growth in the system and reduce iron bacteria and HPC levels.

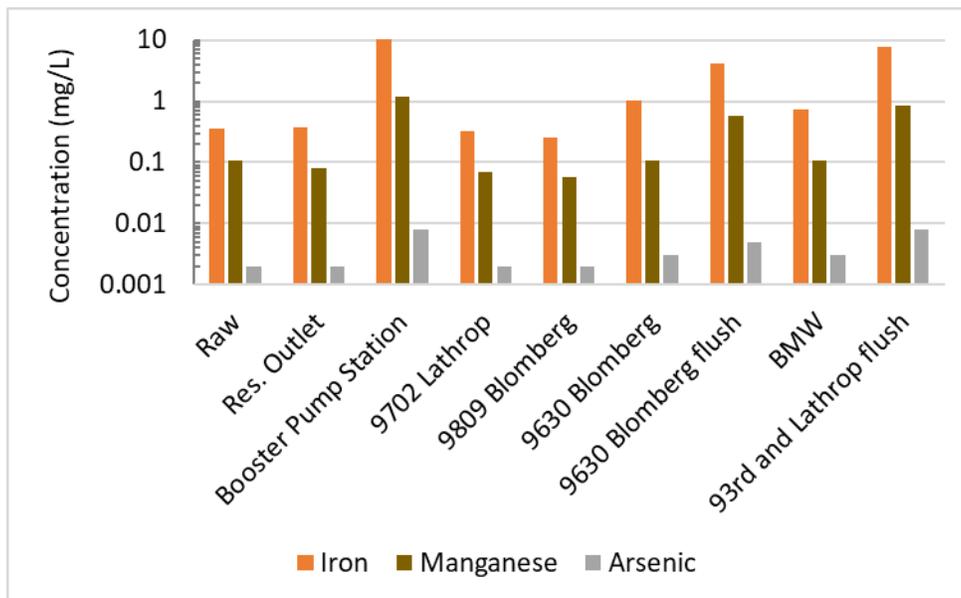
Figure 2. Metals data summary.

Iron, manganese, and arsenic data are presented in Figure 2. The raw water and reservoir outlet water had roughly the same levels of these metals, with concentrations of approximately 0.4 mg/L, 0.1 mg/L, and 0.002 mg/L of iron, manganese, arsenic, respectively. Iron, and to a lesser extent manganese, were found to be significantly higher for the booster pump station sample, the 9630 Blomberg flush sample and the sample collected at 93rd and Lathrop. The pump station sample was collected by connecting a hose to a hose bib on a booster pump which was not in operation at the time. When the valve on the hose bib was opened water was allowed to flow back from the bottom of the reservoir out through the hose. This water was visibly colored and included particles and sediment from the bottom of the reservoir. The 9630 Blomberg flush sample was collected after increasing the flow rate at the hydrant to perform spot flushing at that location. The increased flow rate was sufficient to stir up solids in that part of the system. The

water was found to have a similar reddish-brown color as observed at the booster pump station. Iron and manganese concentrations were found to be an order of magnitude higher than the raw water at the following locations:

- Booster pump station
- 9630 Blomberg flush
- 93rd and Lathrop flush

Although manganese is currently considered an aesthetic concern, recent health effects research has linked elevated manganese to neurological effects in young children. The Canadian Federal-Provincial-Territorial Committee on Drinking Water is considering revised manganese regulations to address these emerging health concerns connecting manganese in drinking water to neurological effects in children. Canada has proposed a health-based maximum acceptable concentration (MAC) of 0.1 mg/L for manganese and an aesthetic objective (AO) of 0.02 mg/L for manganese in drinking water. In the US, the EPA has established a Secondary Maximum Contaminant Level (MCL) of 0.05 mg/L and in 2016, manganese was included on the Final Contaminant Candidate List 4 (CCL4). The concentration of manganese in the Lathrop system raw and reservoir outlet waters were found to be close to the proposed Canadian MAC and above the EPA Secondary MCL.

- If the City intends to continue using the existing well in the Lathrop System, treatment to remove iron and manganese is recommended. Iron and manganese treatment systems are commonly used throughout Western Washington. The systems generally include chlorination upstream of filter vessels which contain either greensand or pyrolusite media. Iron and manganese adsorb to the media resulting in low to non-detectable levels of iron and manganese in the treated water. The media is periodically backwashed resulting in a backwash wastewater rich in iron and manganese. Treatment or disposal of backwash wastewater would need to be assessed. One option would be to construct a backwash holding tank as part of the treatment system from which the backwash wastewater could be pumped to the sewer at a desired flow rate.

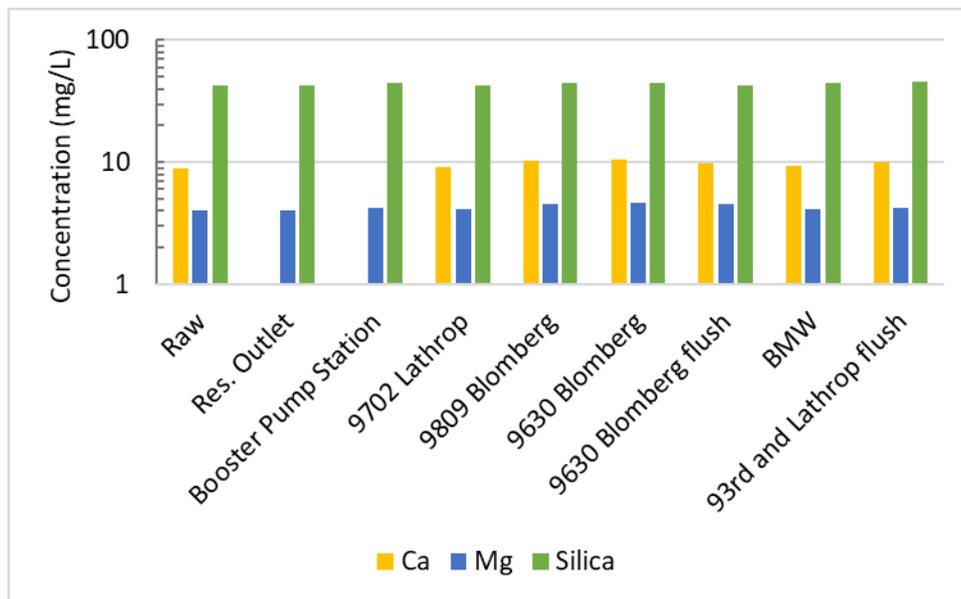
Figure 3. Data for common water quality constituents.

Data for other common elements found in drinking waters are presented in Figure 3. Levels of calcium, magnesium, and silica were found to be very consistent throughout the system with essentially no change in the levels of those constituents among the raw, treated, and distribution system samples. Calcium, magnesium, and silica do not comprise a significant fraction of the sediment in the system.

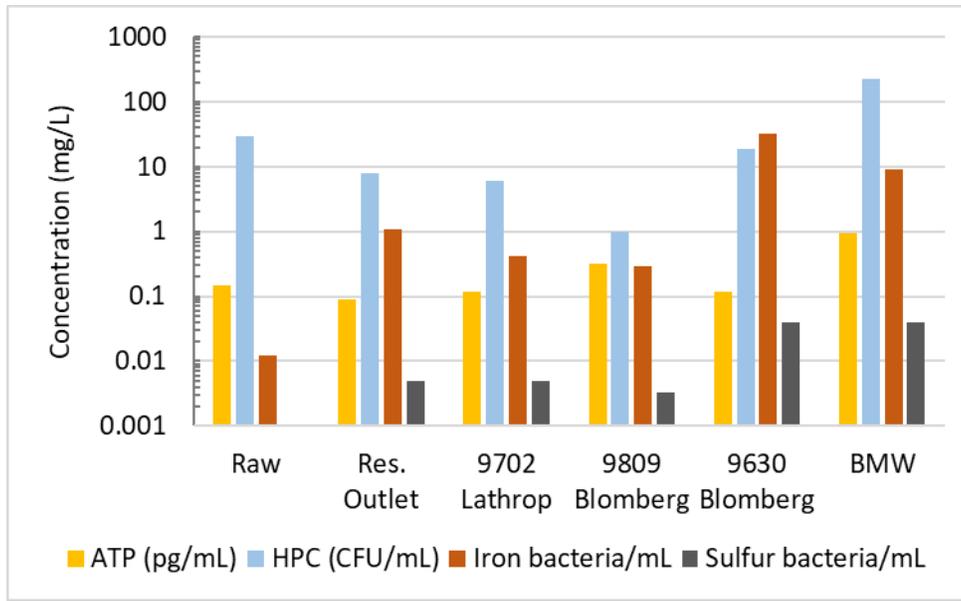
Figure 4. Microbial data summary.

Data for several microbial parameters are presented in Figure 4. ATP levels were found to be reasonably low at all sample locations. Note that ATP levels below 0.5 pg/mL indicate good control, levels between 0.5 and 10 pg/mL indicate the need for a review of preventative strategies, and levels above 10 pg/mL indicate corrective action is required. The raw water had somewhat elevated HPCs and also contained some iron bacteria, although sulfur bacteria were not detected in the raw water. ATP tended to correlate reasonably with HPC and sulfur bacteria although ATP did not correlate with iron bacteria. Further investigation would be required to determine reasons for the lack of correlation between those two parameters.

ATP and HPC of the reservoir outlet water were similar to the raw water, however, iron bacteria were two orders of magnitude higher in the reservoir outlet water compared to the raw water. The reservoir outlet water also contained sulfur bacteria, whereas, sulfur bacteria were not detected in the raw water.

HPCs within the distribution system were found to be significantly higher than the raw water at only the Blue Mountain Way sample location. Iron bacteria were 2 to 3 orders of magnitude higher in the distribution system compared to the raw water. The highest levels of sulfur bacteria were detected at the 9630 Blomberg and at the Blue Mountain Way sample locations.
