City of Tumwater Resource Conservation Management Program (Phase 1)

The GA-WSU Team

Preliminary Baseline Assessment of Tumwater City Hall

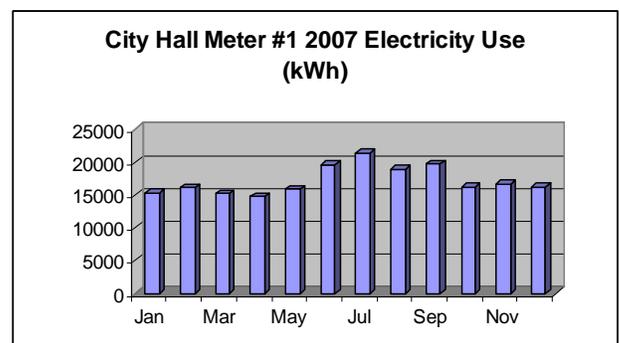
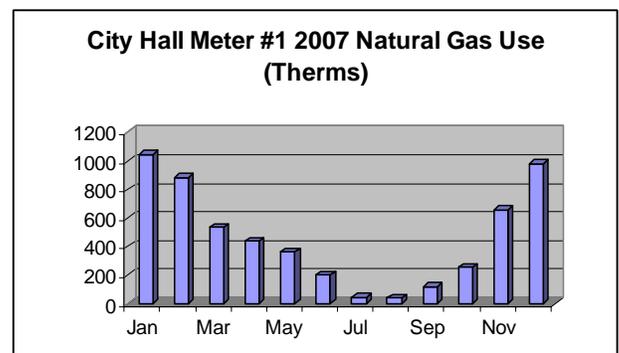
- The average electricity cost was 8.9 cents per kWh, including energy charges, demand charges, fees, credits, and taxes, but ranged from 8.2 to 9.5 cents per kWh.

- The average rate for natural gas was \$1.26 per Therm. The cost was fairly stable through the seasons, the average rate varying primarily because the fixed monthly customer fee of \$17.50 was one percent of the high winter bill but 26 percent of the much lower summer bill.

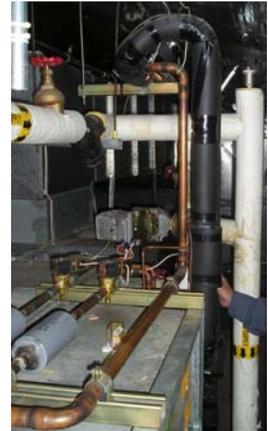
- **Main Floor System:** The air volume of the main fan serving this system is varied as necessary by a variable frequency drive (VFD) controlling the motor speed to maintain a fixed pressure downstream in the main ductwork. First-stage cooling is provided by an economizer and second-stage cooling for this and all the other air handlers in the building is provided by ground-mounted direct-expansion (DX) condensing units. Heating is provided by a hot water coil supplied by the boilers for all air handlers. The air handling unit serving the main floor runs 24/7 in order to condition the police station, which is occupied 24/7.

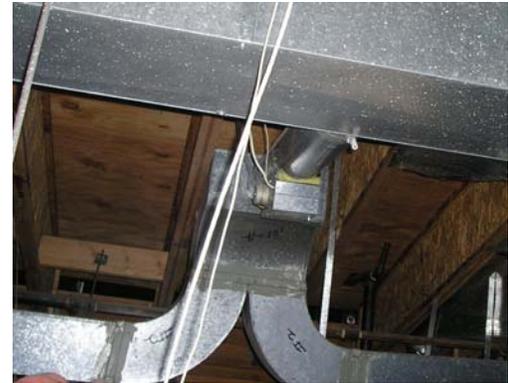
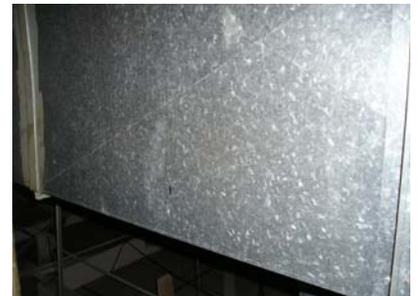
- **Ductwork:** Most of the ductwork is sealed with mastic, which is effective in preventing leaks. However, some recently replaced ducts have not been sealed with mastic

(note the seam at the right on the photo). The access panel in the basement mechanical room was particularly loose.

- Seal ductwork leaks with mastic as necessary. Adjust all duct access panels to seal tightly; the access panel in the basement mechanical room was particularly loose.

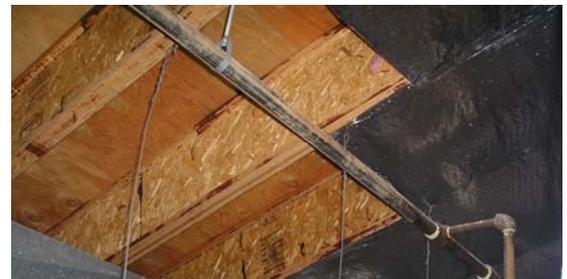
- The walls are wood-framed with masonry exterior.
- The windows are aluminum double-glazed with a U-value of approximately 0.60.
- The roof is wood-framed and sloped with tile, approximately R-30 fiberglass batt insulation with a foil face that minimizes the heat radiating from the roof down to the ceiling. Insulation is installed in between the roof joists so that the attic is part of the insulated shell of the building. In some areas, the insulation has been disturbed and is hanging down in the attic or missing entirely (see photo at right).

- Reinstall the vapor barrier and insulation where they have been disturbed and are hanging down from in the attic. Check for air leaks between the roof and the top of the walls and at the roof peaks. Carefully seal all leaks using non-expanding foam.
- Although the attic space is within the insulated shell of the building, it is not conditioned, so it would be effective to install weatherstripping on attic access doors.

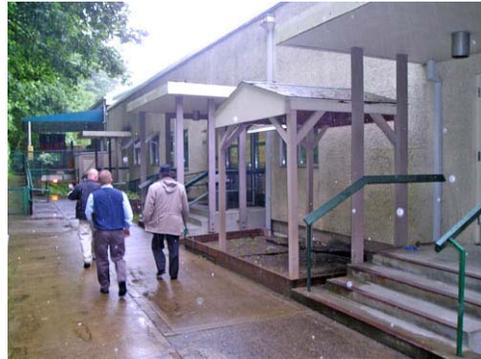
- Building is only partially occupied with Senior Center and Parks and Recreation.
- Building has 30-year plus boiler that appears to be highly inefficient.
- No building automation system
- No central energy management system
- Manual controls on heating/ventilating system, where automated sensors might be more energy efficient. For example, one unoccupied floor had all its heaters turned to “high.” Building occupants at time of walk-through expressed dissatisfaction with temperature control. An automated system could help alleviate this problem.
- Lighting is dated. More efficient lighting options could be obtained, which is consistent with the City of Tumwater’s Climate Action Plan report.

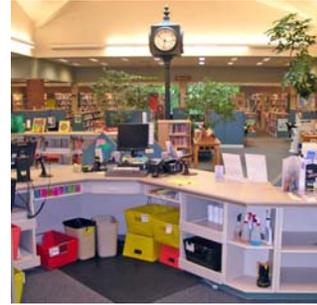
- Building air flow could be an issue. There's a pocket in the ceiling in the center of building, which may capture heat. Ceiling fan may be possibility to push air back in circulation. Ceiling fans don't lower the temperature in a room, but they do provide a breeze that can make occupants feel at least 5 degrees cooler. Ensure the fan blades are rotating counter-clockwise for a cooling effect if fans are the desired option. Moreover, installing a larger fan rather than a smaller one might be beneficial, as it enables the occupant to have more speed settings and cover larger areas while not costing much more than smaller fans to operate.
[Source: Phoenixabout.com]
